GEOTECHNICAL STUDY REPORT

FARMERS LANE WELL IMPROVEMENTS
751 AND 777 FARMERS LANE
SANTA ROSA, CALIFORNIA

5383.07.04.1

January 17, 2017

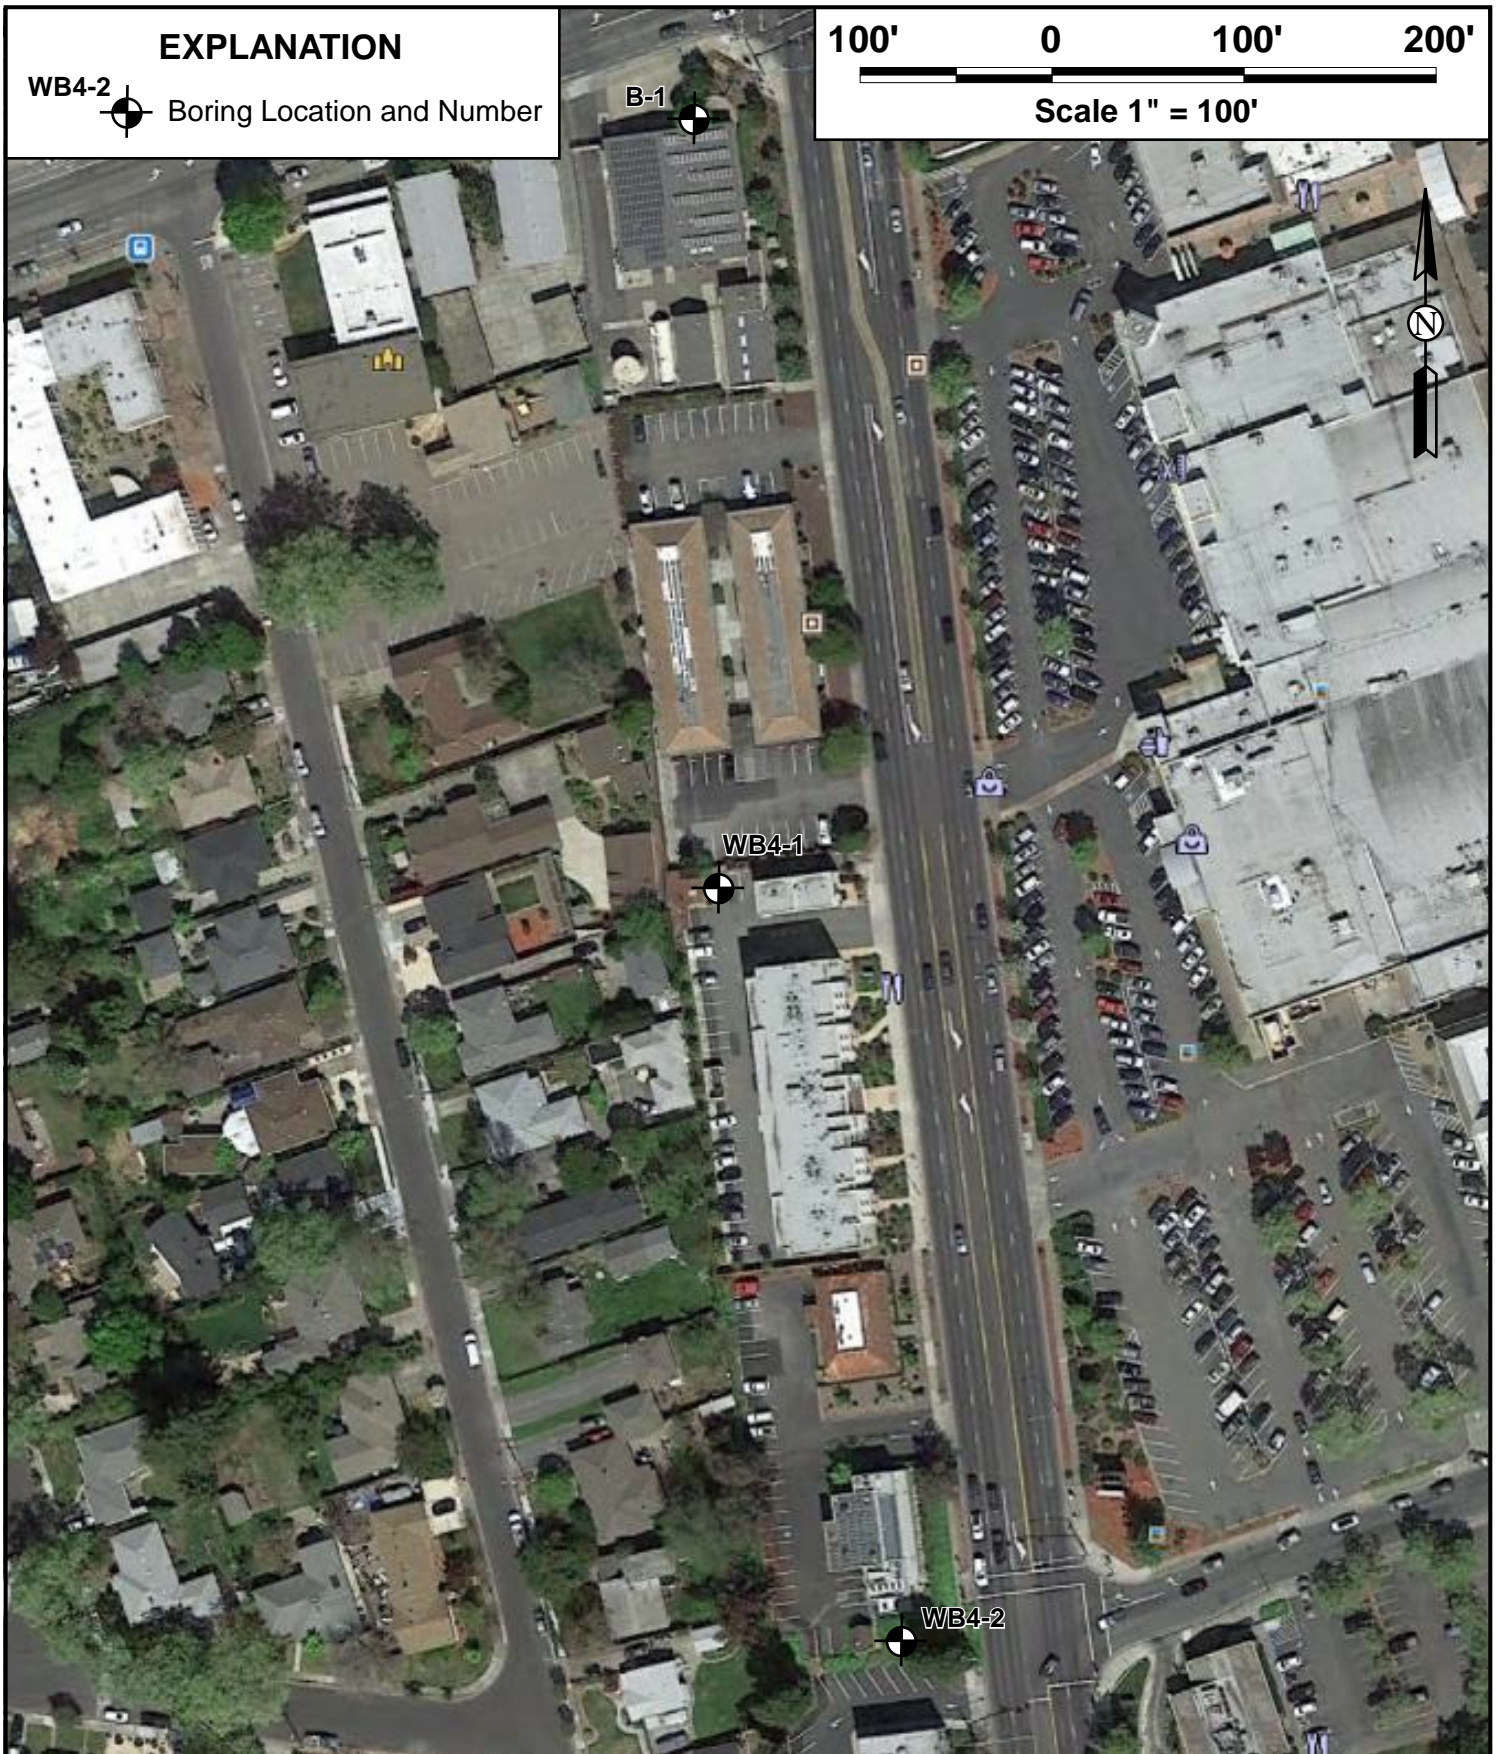
Boring Location and Number

100' 0 100' 200'
Scale 1" = 100'

Reference: Google Earth 2016

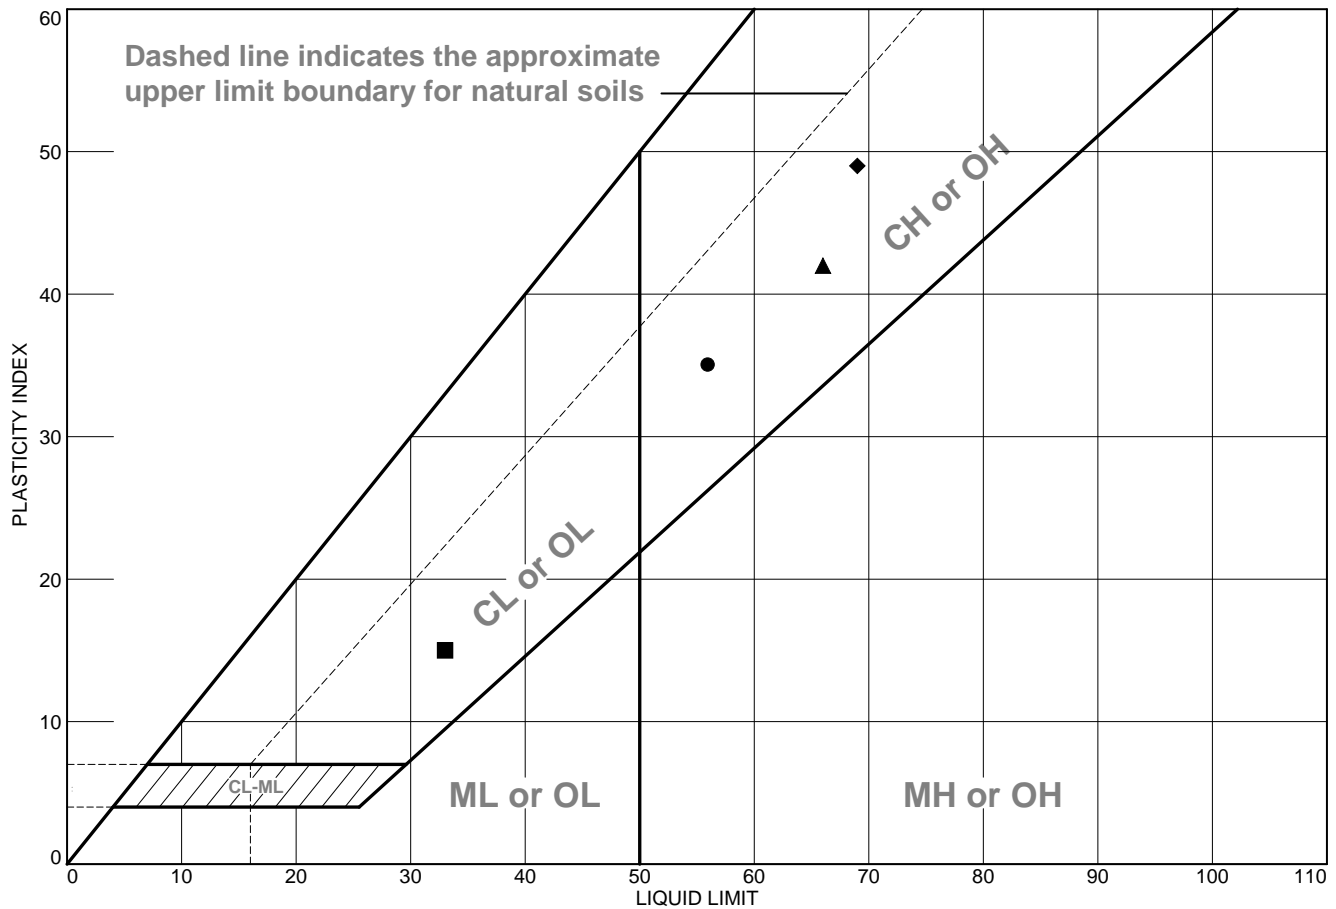
LIQUID AND PLASTIC LIMITS TEST REPORT

MATERIAL DESCRIPTION	LL	PL	PI	%<#40	%<#200	USCS
●	Brn Clay W/ Sand (CH)	56	21	35			CH
■	Grey Clayey Sand (SC)	33	18	15		34.2	SC
▲	Dk Brn Clay W/ Sand (CH)	66	24	42			CH
◆	Blk Clay (CH)	69	20	49			CH

The samples obtained from the borings were transported to our office and re-examined to verify soil classifications, evaluate characteristics and assign tests pertinent to our analysis. Selected samples were laboratory tested to determine their water content, dry density, classification (Atterberg Limits, percent of silt and clay), shear strength and expansion potential (Expansion Index - EI). The test results are presented on the boring logs. Results of the classification tests are presented on Plate 7. Results of the strength tests are presented on Plates 8 through 11.

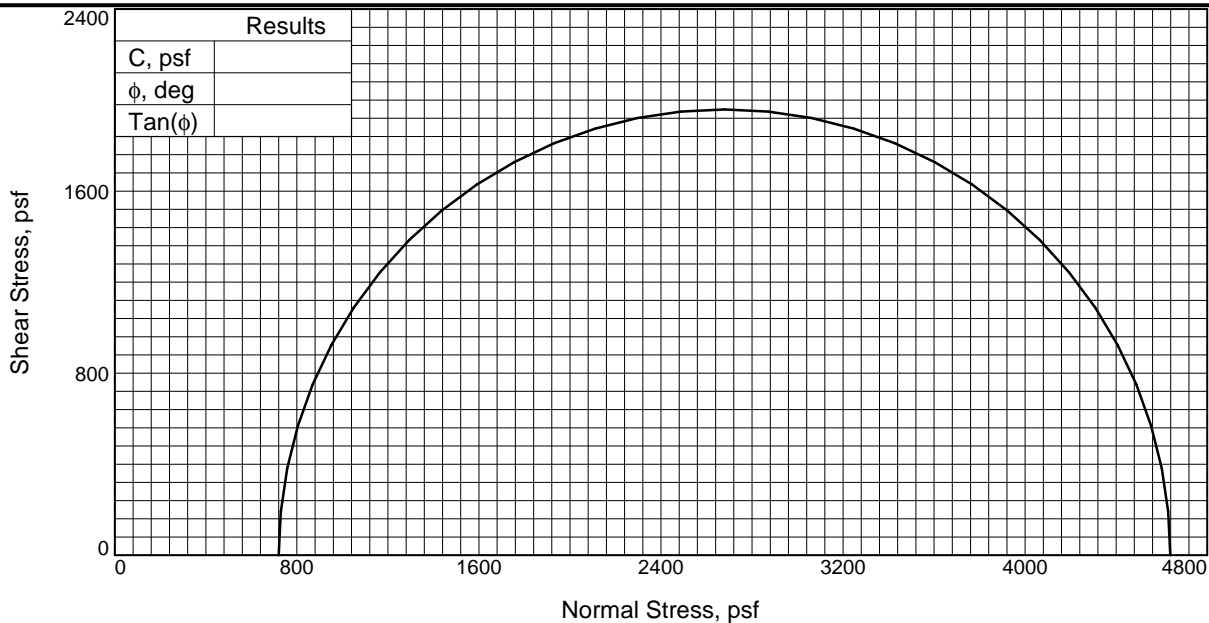
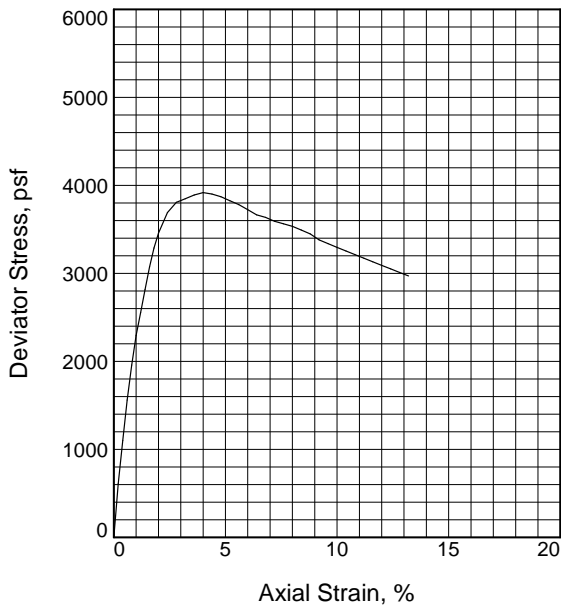
8

Sample No.		1
Initial	Water Content, %	24.5
	Dry Density, pcf	70.6
	Saturation, %	47.7
	Void Ratio	1.3873
	Diameter, in.	2.37
	Height, in.	5.00
At Test	Water Content, %	24.5
	Dry Density, pcf	70.6
	Saturation, %	47.7
	Void Ratio	1.3873
	Diameter, in.	2.37
	Height, in.	5.00
Strain rate, in./min.		0.06
Back Pressure, psf		0
Cell Pressure, psf		720
Fail. Stress, psf		3918
Ult. Stress, psf		3918
σ_1 Failure, psf		4638
σ_3 Failure, psf		720

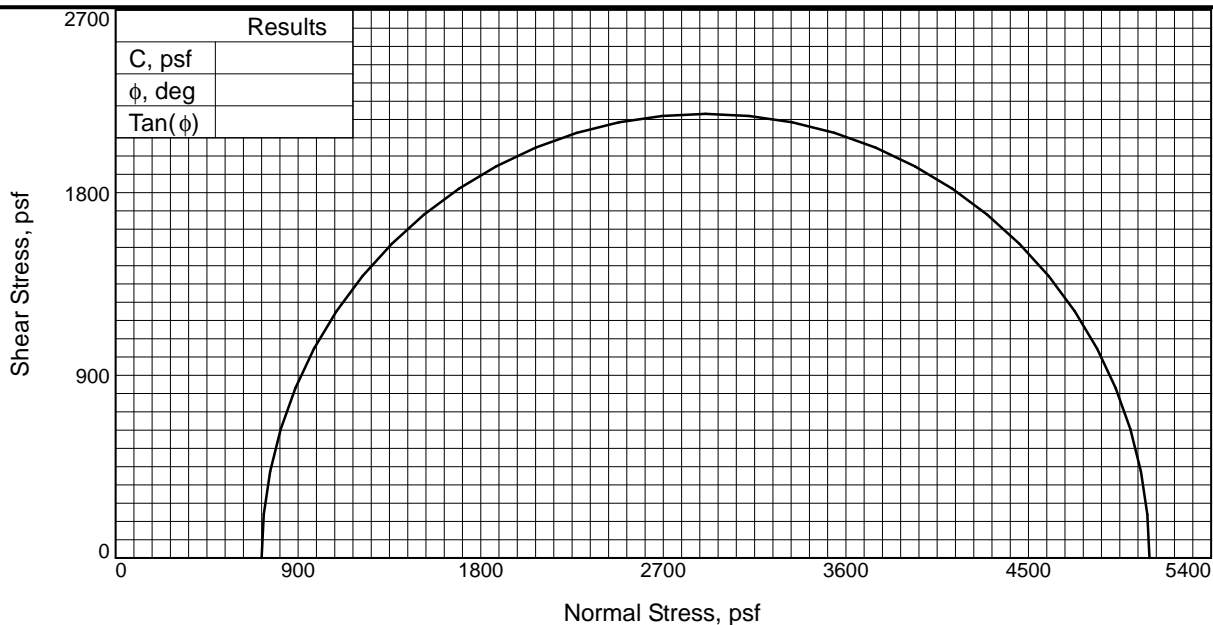
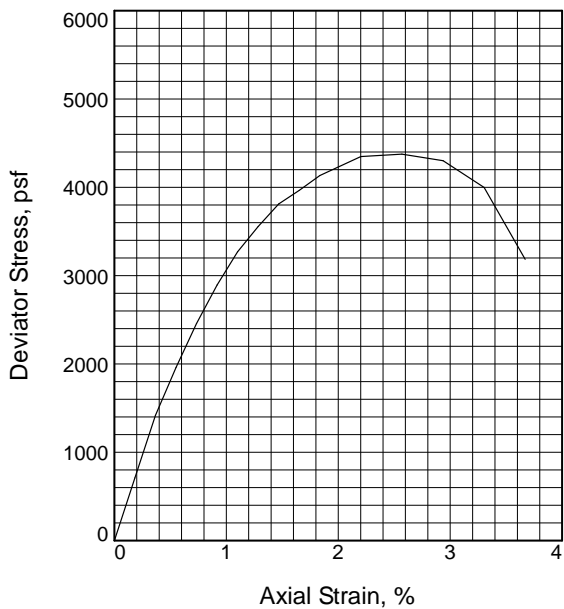
9

Sample No.		1
Initial	Water Content, %	35.7
	Dry Density, pcf	79.1
	Saturation, %	85.2
	Void Ratio	1.1322
	Diameter, in.	2.38
	Height, in.	5.45
At Test	Water Content, %	35.7
	Dry Density, pcf	79.1
	Saturation, %	85.2
	Void Ratio	1.1322
	Diameter, in.	2.38
	Height, in.	5.45
Strain rate, in./min.		0.06
Back Pressure, psf		0
Cell Pressure, psf		720
Fail. Stress, psf		4376
Ult. Stress, psf		4376
σ_1 Failure, psf		5096
σ_3 Failure, psf		720

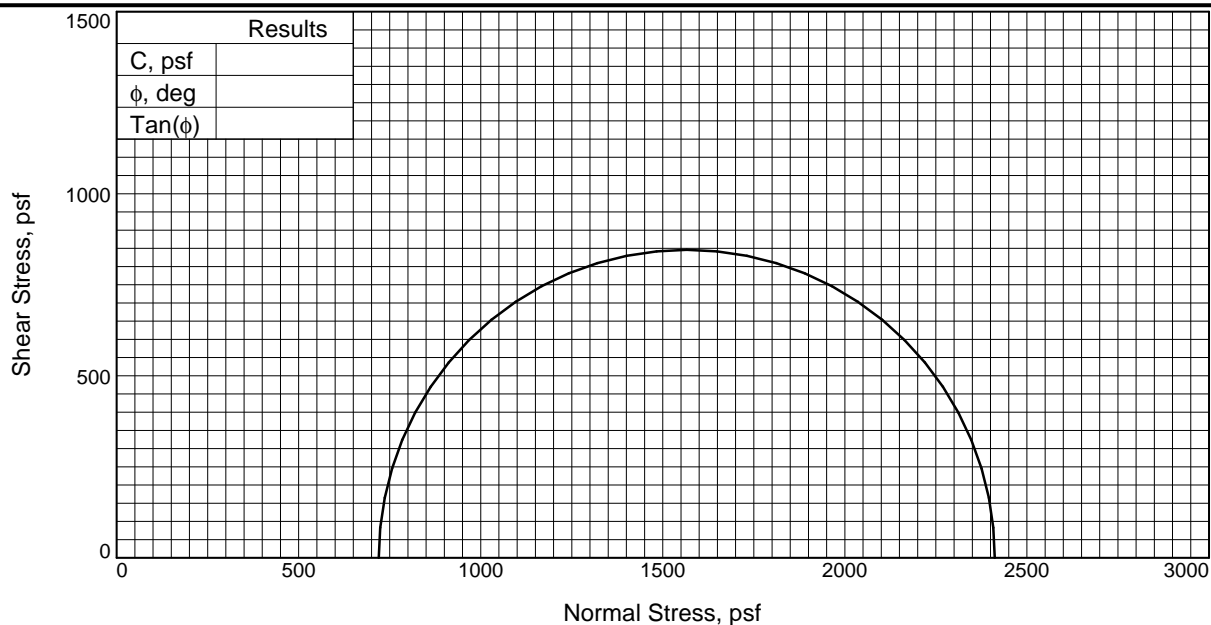
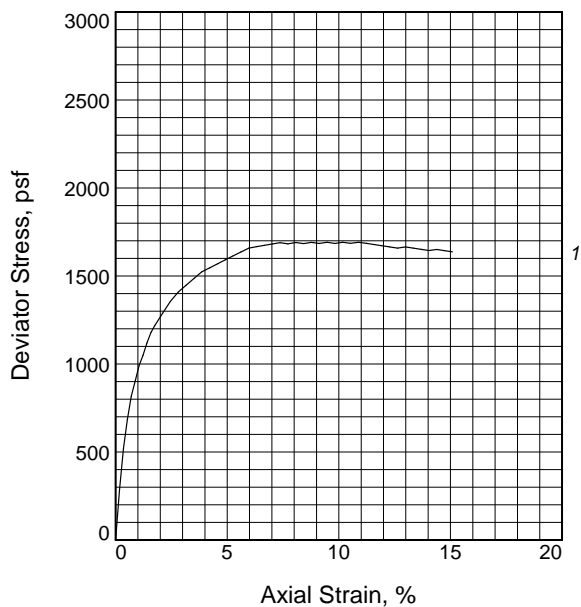
10

Sample No.		1
Initial	Water Content, %	37.1
	Dry Density, pcf	83.8
	Saturation, %	99.0
	Void Ratio	1.0121
	Diameter, in.	2.37
	Height, in.	5.70
At Test	Water Content, %	37.1
	Dry Density, pcf	83.8
	Saturation, %	99.0
	Void Ratio	1.0121
	Diameter, in.	2.37
	Height, in.	5.70
Strain rate, in./min.		0.06
Back Pressure, psf		0
Cell Pressure, psf		720
Fail. Stress, psf		1692
Ult. Stress, psf		1692
σ_1 Failure, psf		2412
σ_3 Failure, psf		720

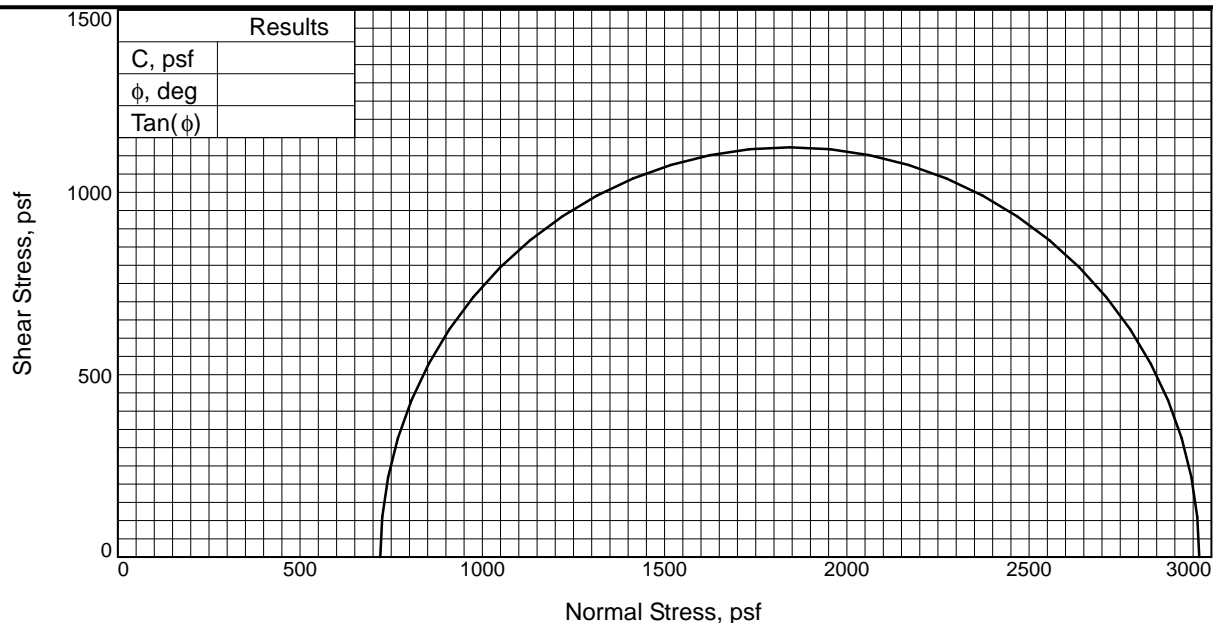
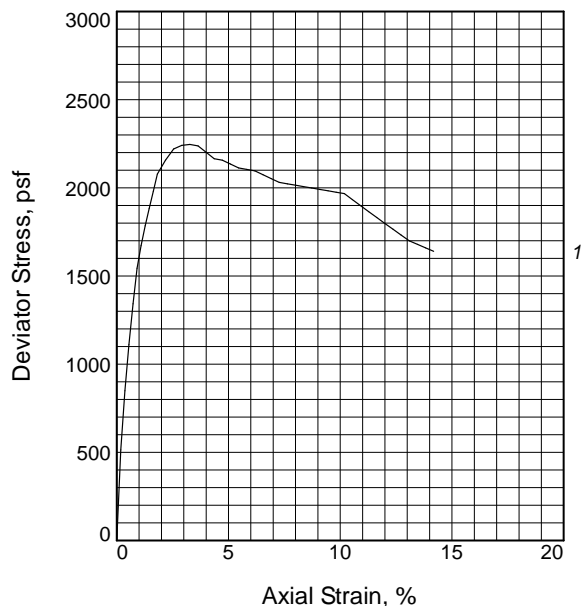
Sample No.		1
Initial	Water Content, %	36.4
	Dry Density, pcf	82.8
	Saturation, %	94.8
	Void Ratio	1.0359
	Diameter, in.	2.39
	Height, in.	5.50
At Test	Water Content, %	36.4
	Dry Density, pcf	82.8
	Saturation, %	94.8
	Void Ratio	1.0359
	Diameter, in.	2.39
	Height, in.	5.50
Strain rate, in./min.		0.06
Back Pressure, psf		0
Cell Pressure, psf		720
Fail. Stress, psf		2247
Ult. Stress, psf		2247
σ_1 Failure, psf		2967
σ_3 Failure, psf		720
